GE Bypass Valve Replacement

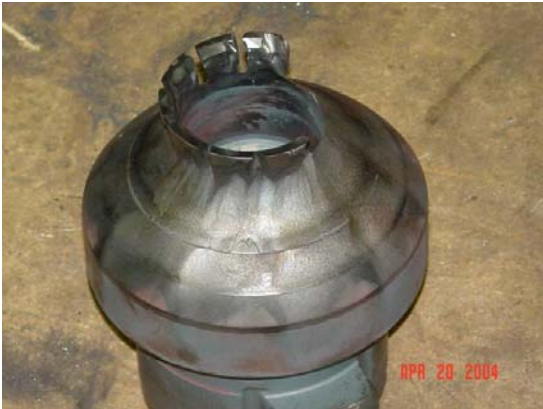
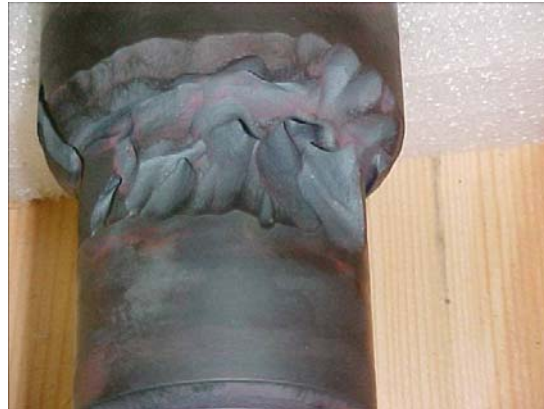
Do you recognize these erosion patterns?

If you have a GE MSV bypass valve you probably do. The valve head and stem above were in service for 75 hours of operation on the bypass valve over a period of a couple of years. Wouldn't you like to get off of the "frequent inspection / repair / replacement / risk of failure" merry-go-round?

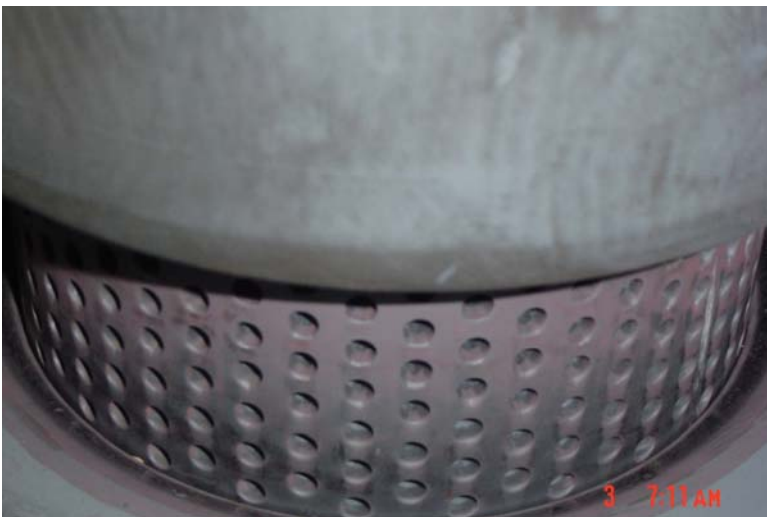
This is the Toshiba Multi-hole bypass valve. The holes you see are the entry holes for steam flow, and the side you are viewing is in line with the main steam entry line. If you look closely at the holes you will see the wear that has occurred during operation on this valve.

This valve has been on bypass valve operation for 200 hours on the same unit that did the damage above.

The Multi-hole bypass valve is successful because it is a total redesign of the steam flow within the valve. There is no piece in the steam flow against which the steam must change direction. There is so little wear that it is often difficult to detect the difference from one outage to the next.

And, the valve is designed such that if it were to erode severely, it does not have a tendency to break into pieces that may fly through your turbine.
